### Issue No. 03/2012: Complaints after an oil change in VW 1.2 and 1.4 TSI engines

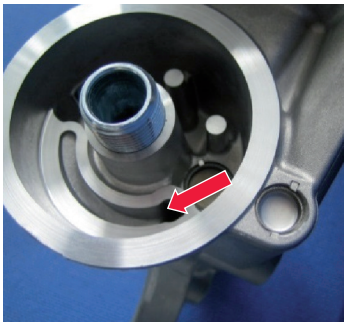
Figure 1: View of the flange on the engine side with the anti-drain back plate

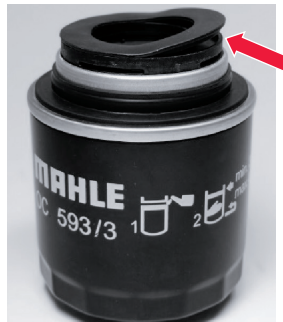
One of the gaskets on the filter is pushed onto the so-called anti-drain back plate (see Figure 1) in the flange by means of spring force in order to provide a seal when screwed on (see Figure 2). This mechanism only opens the drain when the filter is loosened during an oil change. The remaining engine oil drains completely into the oil sump and can be

Figure 2: The upper gasket (raised for the sake of clarity) seals the drainage mechanism in the flange.

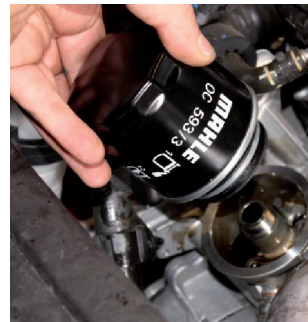
Figure 3: When loosening the old filter, make sure that no engine oil gets onto the belt drive or into the alternator.

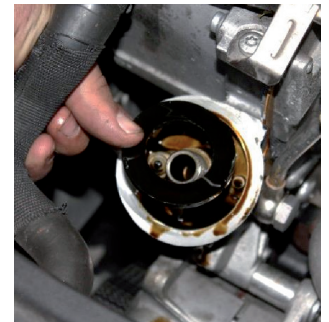
disposed of. It is possible that the old sealing ring sticks to the flange and is overlooked due to the used, black oil (see Figure 4). Nevertheless, the new filter can still be tightened without any noticeable problems.

Only once the engine is running will the oil pressure warning light up, for example, and flange or filter leakage occur. Under certain operating conditions, the oil pressure can drop so far that rattling noises from the timing chain tension adjuster and hydraulic lifters become clearly noticeable.

Figure 4: The old gasket can remain stuck in the flange and must always be removed.

**IMPORTANT!** Before installing the new filter, it is essential to locate the old gasket and remove it from the flange by hand, if necessary. It is also important to always coat the new sealing rings with clean engine oil prior to assembly.
