## Issue no. 5/2014: KL 82 – strange noises after replacing the filter?

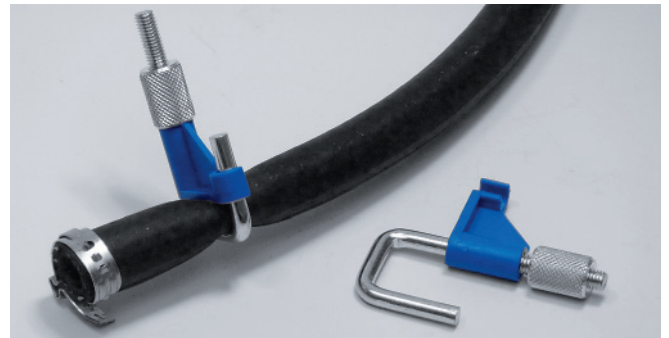
Figure 1: Hose clamps

1. Before you start removing the filter, please remember to wear the appropriate protective clothing (safety goggles, gloves, etc.) when working on the fuel system.
2. In order to reduce any residual pressure in the tank, first briefly open the tank cap.
3. Before removing the lines, shut all connections on the line filter using suitable tools (Fig. 1). This prevents fuel from escaping and the lines from emptying—and thus additional air from penetrating the fuel lines.
4. During installation, pay close attention to the flow direction (Fig. 2) printed on the filter. Equally important: do not interchange the fuel lines and always replace damaged hoses and clamps.
5. After the filter replacement, check all connections and fittings for leaks and tightness.

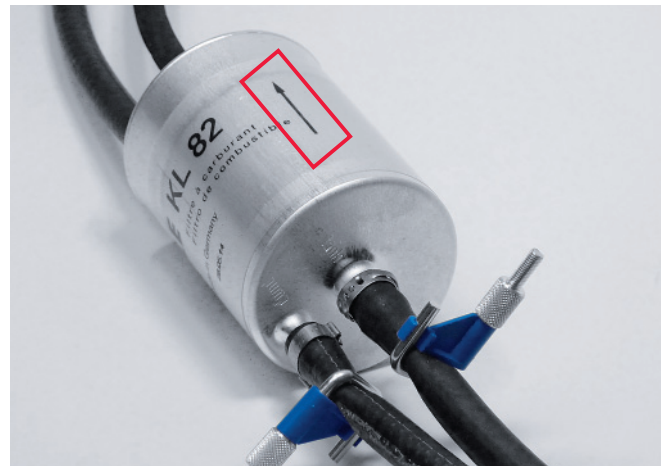
Figure 2: Shut the fuel lines to prevent them from emptying
