THE WAY OF INSTALLATION OF THIS KIND OF HUB ASSEMBLY IS DIFFERENT FROM OTHER HUB ASSEMBLY. THE WRONG WAY OF INSTALLATION WILL DAMAGE ITS INNER STRUCTURE AND SHORTEN THE LIFE TIME OF THE PRODUCT. THE EFFECT OF THE WRONG INSTALLATION INITIALLY SHOWS UP AS SHOWN BELOW.

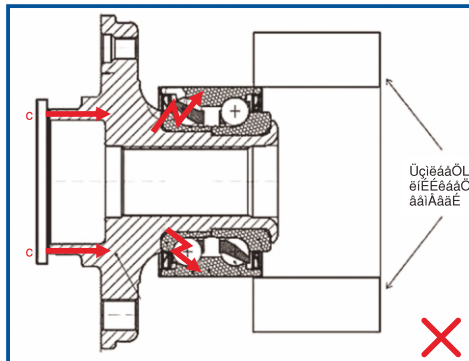
2. As shown on the picture, wrong force application will damage the inner structure and lead to the problems mentioned above.

1. This kind of hub assembly needs to be installed with special tools to avoid damages to the inner structure of the bearing. The force has to be applied on the outer ring of the bearing urgently. Otherwise with initial effect the product will make noise, can get play and the lifetime will be shortened immediately.
